The effects of biological geotextiles on gully stabilization in São Luís, Brazil

Natural Hazards

DOI 10.1007/s11069-014-1449-0

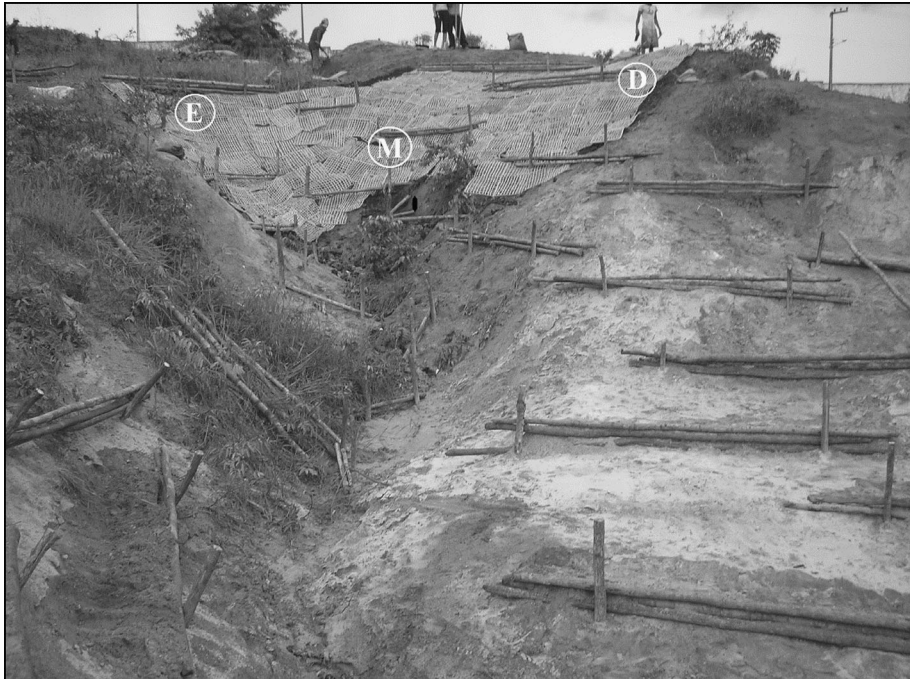
Fig. 2 Area 3 of the rehabilitated gully, with work in progress. *E*, *M* and *D* were reshaped exclusively by manual labour, São Luís, Brazil (LAGESOLOS 2008)

The rehabilitation work in Sacavém was divided into three areas, because of local relief characteristics. Areas 1–3 (Fig. 4) were constructed by men and the tractor; the upper parts of areas 4–8 (Fig. 4) were constructed using the tractor and areas E, M and D (Fig. 2) were reshaped exclusively by manual labour.

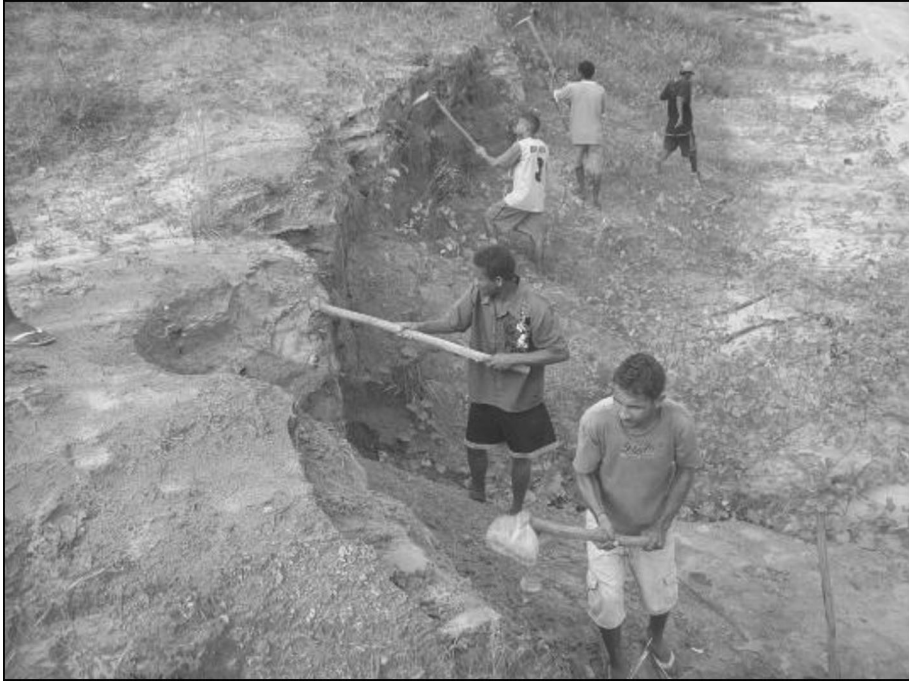
Fig. 3 Men working with hand-held tools, São Luís (LAGESOLOS 2008)

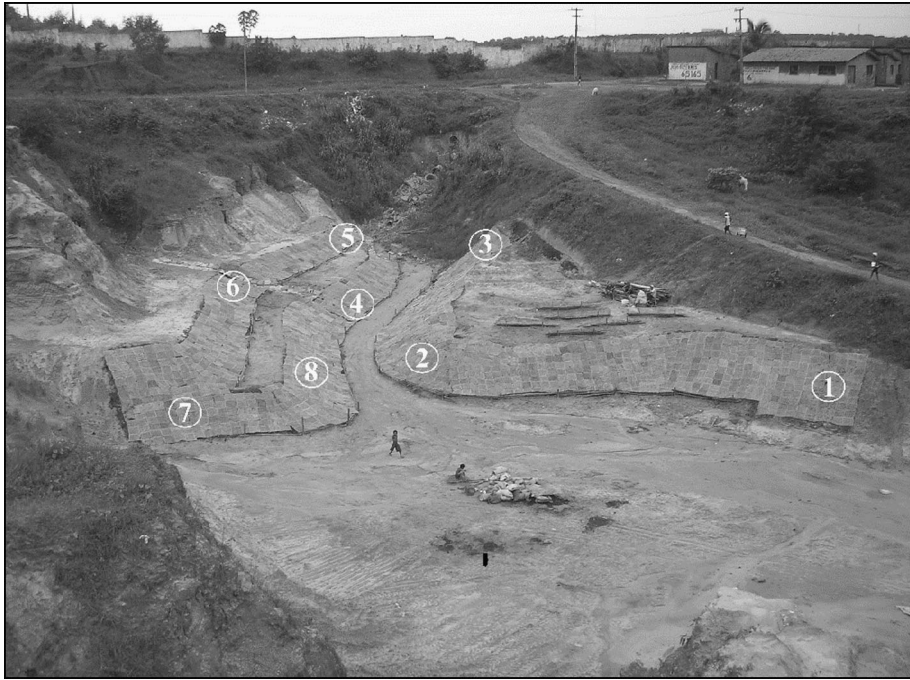
Fig. 4 Rehabilitated areas with cover of Buriti geotextiles, Sacavém, São Luís (areas 1–3 were constructed with men and tractors; upper areas 4–8 were constructed using a tractor) (LAGESOLOS 2008)

In Part 1 (Fig. 4: areas 1–3), the team used biological geotextiles and organic matter from decomposing palms, seeds and inserted barriers of wooden stakes along contours. This area had formed due the concentration of run-off from the street above the gully (Fig. 5).

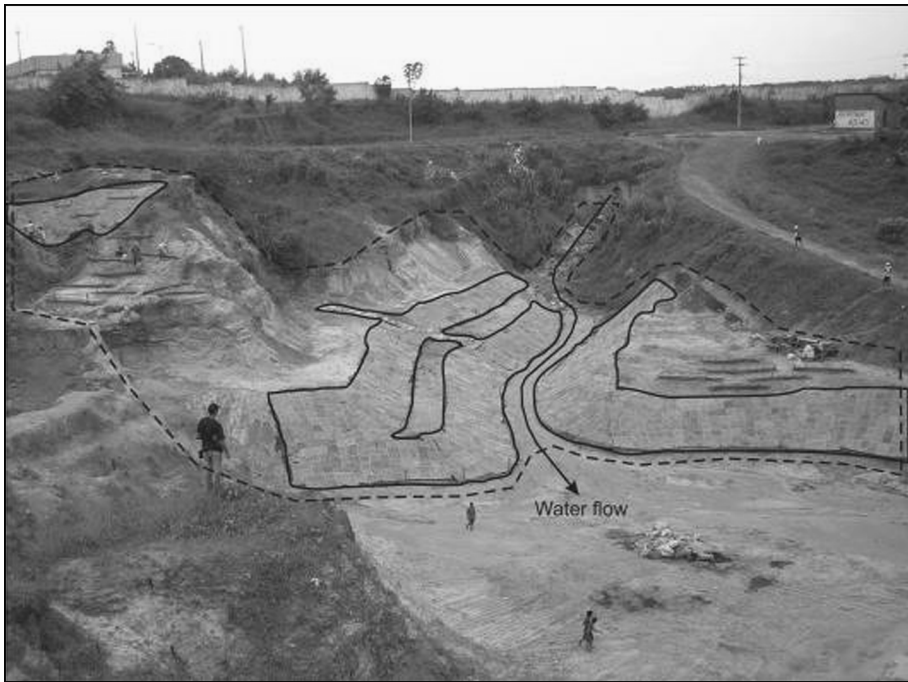
Fig. 5 Continuous lines areas rehabilitated with Buriți palm mats. Hatched lines the rehabilitated area in Sacavém (LAGESOLOS 2008)

Area 3 was made by men, using Buriti biological geotextiles, organic matter from decomposing organic material (palm trees and leaves), wooden stakes and the planting of shrubs, as the area was inaccessible to the tractor. To reshape the internal part of the gully, we used techniques to minimize water flow energy, using barriers of wooden stakes (Fig. 2) and the application of biological geotextiles, grass seeds and organic matter from decomposing palm leaves. On the barriers, Sabiá bushes were planted to stabilize the topsoil. The rehabilitated area in Sacavém is ~2,000, and ~800 m² is covered with Buriti biological geotextiles (Fig. 5).

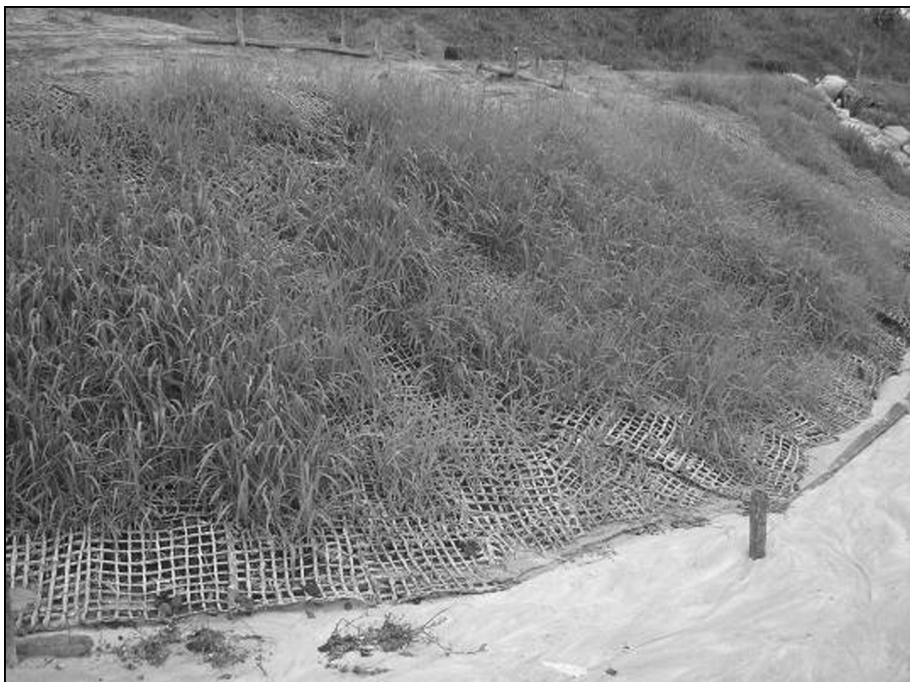
Fig. 7 Grass development, one month after rehabilitation (16/04/08), at Sacavém gully (LAGESOLOS 2008)

vegetation growth, in 1 month (Figs. 6, 7), due to tropical rains, together with the techniques applied on the reshaped gully. Li et al. (2006) found similar results in Shanghai (China) and demonstrated the advantages of soil bioengineering for riverbank stabilization. These include the following: (a) the establishment of a soil–root matrix which provides progressively increasing strength and structural stability, (b) the ecological integrity and biodiversity of aquatic system are restored and protected, (c) plants have the ability to be self-healing and self-reinforcing and (d) the landscape is dramatically improved by re-vegetation.
